# Manhole Inspection Summary

Manhole # S47II\_048MH

Insp Date: **5/1/08 7:43 AM**

**Location** Address: **Port St**

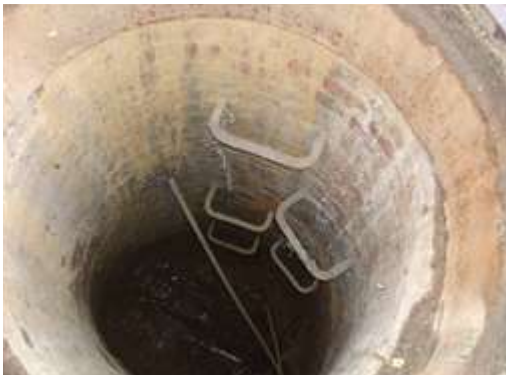
Defect 1

Infiltration: ☐ None ☐ Joint ☐ Cracks ☐ Mortar ☐ Roots ☒ **Wall**

Infiltration

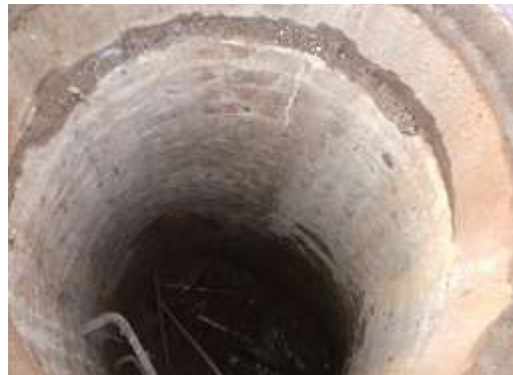
Defect 2

Frame Leaks

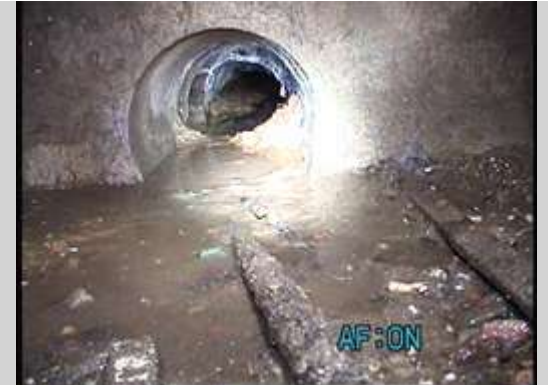
12 O'Clock Outflow

8 in. Circular Gravity Sewer  
Pipe Out @ 12 O'Clock

Deposits: ☐ None ☒ **Mud** ☐ Sludge ☐ Debris ☐ Grease

Silt Depth: **2** (in.) Deposits Extent: **Light**
